**Flood Control Project Maintenance
Levee Inspections**

Fall 2018 Levee Maintenance Deficiency Summary Report

**Flood Control Project Maintenance
Levee Inspections**
LMA District Cover Sheet
Fall 2018 Levee Inspection Results

Reclamation District No. 2060 Hastings

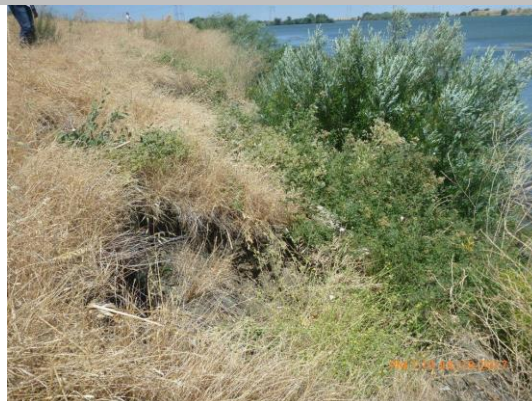
Photo 1 of 3 : FA_2018_RD2060_243_27_20180925_00034.jpg

LM Start	2.12	Rating **	A/W	Issue No.	27
LM End	2.15	Issue Type +	Ma	Location *	
Category	Supplemental			GPS Latitude/Longitude	
				Start	End
Item	2017 Storm Damage			38.282733 °	38.282403 °
				-121.717683 °	-121.717428 °
DWR ID	DWR_RD2060_03_f_2017_27				
Comment Code					
Inspector Comment					
Levee Evaluation Comments					
Description:Erosion commences approximately 1/4 of the way down the slope and results in slippage into the waterside toe.					
Site ID No:397					
Site Designation:LMA-224					
Repair Type: Erosion					
Rating:Serious					
Field Date:7/18/2017					
Notes: Benched erosion with large cracks on slope above. Light veg in erosion.

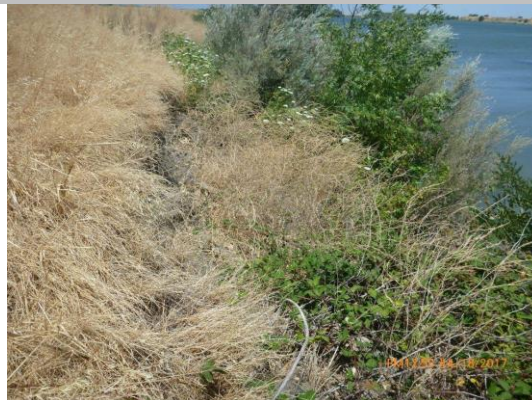
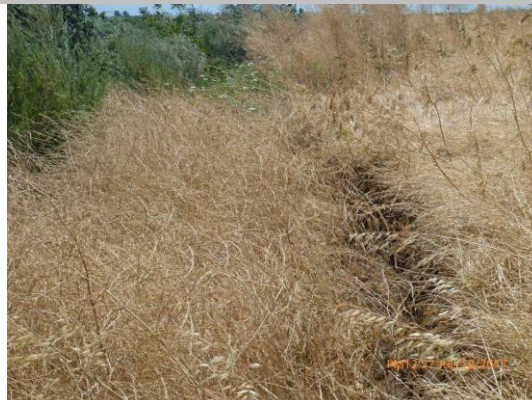
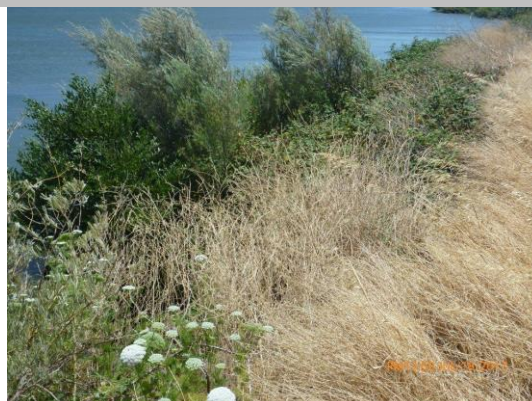
LM Start	2.19	Rating **	A/W	Issue No.	28
LM End	2.22	Issue Type +	Ma	Location *	
Category	Supplemental			GPS Latitude/Longitude	
				Start	End
Item	2017 Storm Damage			38.281839 °	38.281486 °
				-121.716964 °	-121.716661 °
DWR ID	DWR_RD2060_03_f_2017_28				
Comment Code					
Inspector Comment					
Levee Evaluation Comments					
Description:Erosion commences approximately 1/4 of the way down the slope and results in slippage into the waterside toe.					
Site ID No:398					
Site Designation:LMA-225					
Repair Type: Erosion					
Rating:Serious					
Field Date:7/18/2017					
Notes: Erosion is near vertical with light veg. Existing rip rap to the left of site.

LM Start	2.19	Rating **	A/W	Issue No.	28 (cont)
LM End	2.22	Issue Type +	Ma	Location *	
Category	Supplemental			GPS Latitude/Longitude	
				Start	End
Item	2017 Storm Damage			38.281839 °	38.281486 °
				-121.716964 °	-121.716661 °
DWR ID	DWR_RD2060_03_f_2017_28				
Comment Code					
Inspector Comment					
Levee Evaluation Comments					
Description:Erosion commences approximately 1/4 of the way down the slope and results in slippage into the waterside toe.					
Site ID No:398					
Site Designation:LMA-225					
Repair Type: Erosion					
Rating:Serious					
Field Date:7/18/2017					
Notes: Erosion is near vertical with light veg. Existing rip rap to the left of site.

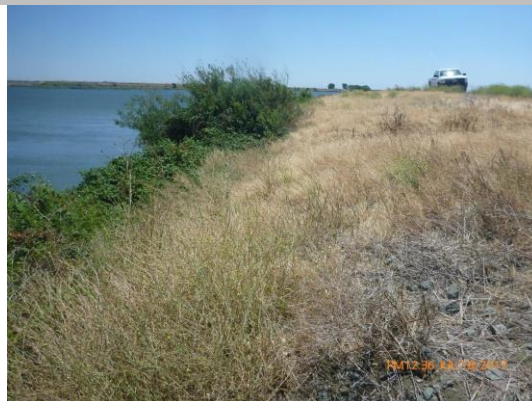
Photo 1 of 3 : FA_2018_RD2060_243_29_20180925_00040.jpg

LM Start	2.30	Rating **	M	Issue No.	29
LM End	2.33	Issue Type +	Ma	Location *	
Category	Supplemental			GPS Latitude/Longitude	
				Start	End
Item	2017 Storm Damage			38.280667 °	38.280467 °
				-121.715664 °	-121.715242 °
DWR ID	DWR_RD2060_03_f_2017_29				
Comment Code					
Inspector Comment					
Levee Evaluation Comments					
Description:Erosion commences approximately halfway down the slope and results in slippage into the waterside toe.					
Site ID No:399					
Site Designation:LMA-226					
Repair Type: Erosion					
Rating:Area of Concern					
Field Date:7/18/2017					
Notes: Vertical erosion at high water mark.

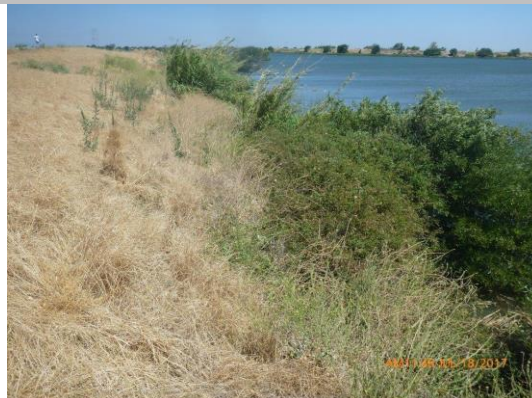
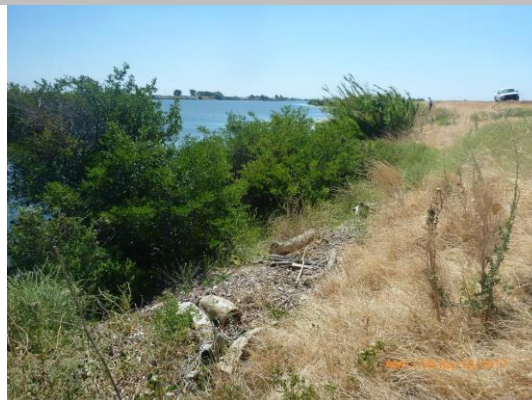
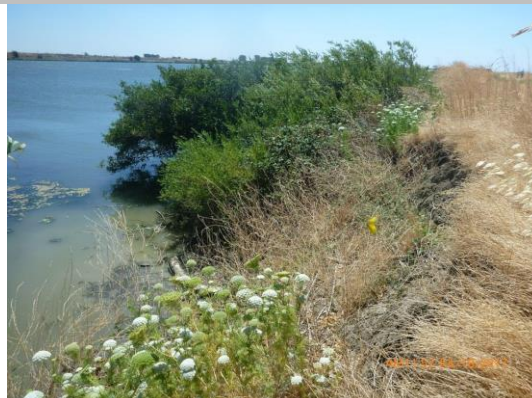
LM Start	2.36	Rating **	M	Issue No.	31
LM End	2.43	Issue Type +	Ma	Location *	
Category	Supplemental			GPS Latitude/Longitude	
				Start	End
Item	2017 Storm Damage			38.280208 °	38.279336 °
				-121.714853 °	-121.714172 °
DWR ID	DWR_RD2060_03_f _ 2017_31				
Comment Code					
Inspector Comment					
Levee Evaluation Comments					
Description:Erosion commences approximately halfway down the slope and results in slippage into the waterside toe.					
Site ID No:400					
Site Designation:LMA-227					
Repair Type: Erosion					
Rating:Area of Concern					
Field Date:7/18/2017					
Notes: Steep cut but protected with heavy woody veg.

LM Start	2.36	Rating **	M	Issue No.	31 (cont)	
LM End	2.43	Issue Type +	Ma	Location *		
Category	Supplemental			GPS Latitude/Longitude		
				Start		End
Item	2017 Storm Damage			38.280208 °		38.279336 °
				-121.714853 °		-121.714172 °
DWR ID	DWR_RD2060_03_f _ 2017_31					
Comment Code						
Inspector Comment						
Levee Evaluation Comments						
Description:Erosion commences approximately halfway down the slope and results in slippage into the waterside toe.						
Site ID No:400						
Site Designation:LMA-227						
Repair Type: Erosion						
Rating:Area of Concern						
Field Date:7/18/2017						
Notes: Steep cut but protected with heavy woody veg.

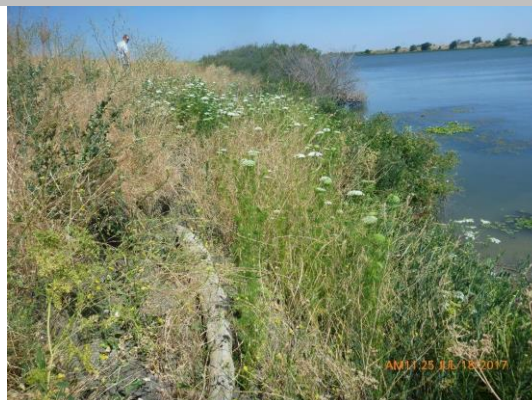
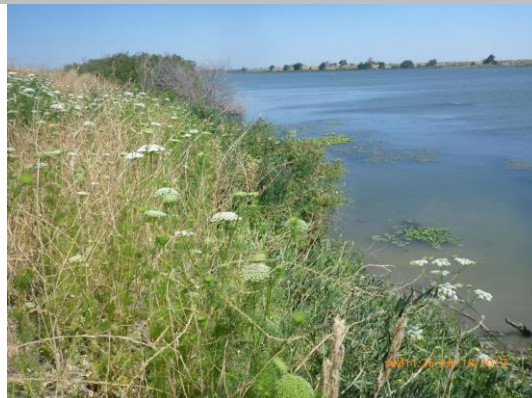
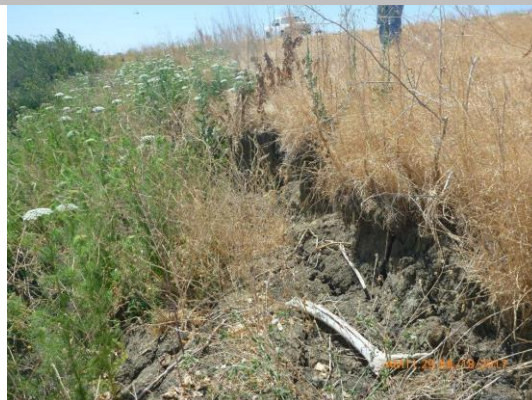
LM Start	2.47	Rating **	M	Issue No.	32
LM End	2.49	Issue Type +	Ma	Location *	
Category	Supplemental			GPS Latitude/Longitude	
				Start	End
Item	2017 Storm Damage			38.278794 °	38.278533 °
				-121.713703 °	-121.713453 °
DWR ID	DWR_RD2060_03_f _ 2017_32				
Comment Code					
Inspector Comment					
Levee Evaluation Comments					
Description:Erosion commences approximately halfway down the slope and results in sloughing into the waterside toe.					
Site ID No:401					
Site Designation:LMA-228					
Repair Type: Erosion					
Rating:Area of Concern					
Field Date:7/18/2017					
Notes: Erosion and sloughing. Heavy veg flanking both sides.

LM Start	2.47	Rating **	M	Issue No.	32 (cont)
LM End	2.49	Issue Type +	Ma	Location *	
Category	Supplemental			GPS Latitude/Longitude	
				Start	End
Item	2017 Storm Damage			38.278794 °	38.278533 °
				-121.713703 °	-121.713453 °
DWR ID	DWR_RD2060_03_f _ 2017_32				
Comment Code					
Inspector Comment					
Levee Evaluation Comments					
Description:Erosion commences approximately halfway down the slope and results in sloughing into the waterside toe.					
Site ID No:401					
Site Designation:LMA-228					
Repair Type: Erosion					
Rating:Area of Concern					
Field Date:7/18/2017					
Notes: Erosion and sloughing. Heavy veg flanking both sides.

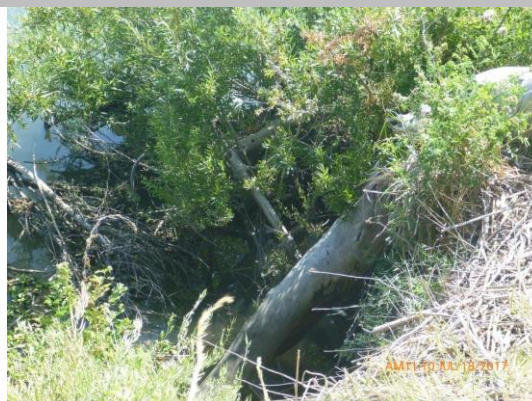
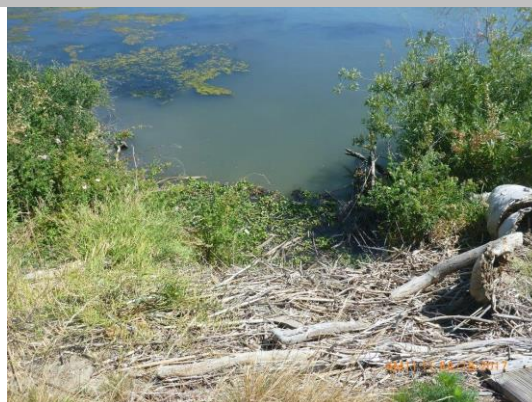
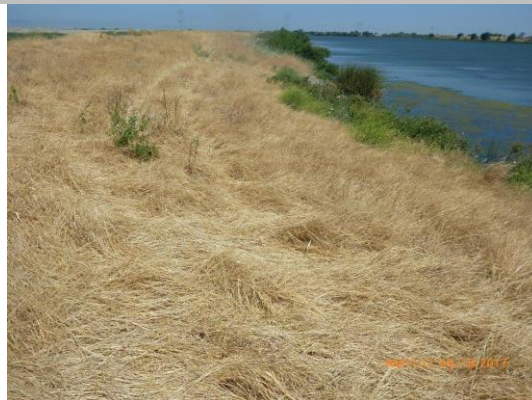
LM Start	2.55	Rating **	M	Issue No.	33
LM End	2.55	Issue Type +	Ma	Location *	
Category	Supplemental			GPS Latitude/Longitude	
				Start	End
Item	2017 Storm Damage			38.277956°	38.277928°
				-121.712814°	-121.712775°
DWR ID	DWR_RD2060_03_f_2017_33				
Comment Code					
Inspector Comment					
Levee Evaluation Comments					
Description:Erosion commences approximately halfway down the slope and extends to the waterside toe.					
Site ID No:402					
Site Designation:LMA-229					
Repair Type: Erosion					
Rating:Area of Concern					
Field Date:7/18/2017					
Notes: Small but deep vertical cut down to water.

LM Start	2.55	Rating **	M	Issue No.	33 (cont)	
LM End	2.55	Issue Type +	Ma	Location *		
Category	Supplemental			GPS Latitude/Longitude		
				Start		End
Item	2017 Storm Damage			38.277956 °		38.277928 °
				-121.712814 °		-121.712775 °
DWR ID	DWR_RD2060_03_f _ 2017_33					
Comment Code						
Inspector Comment						
Levee Evaluation Comments						
Description:Erosion commences approximately halfway down the slope and extends to the waterside toe.						
Site ID No:402						
Site Designation:LMA-229						
Repair Type: Erosion						
Rating:Area of Concern						
Field Date:7/18/2017						
Notes: Small but deep vertical cut down to water.

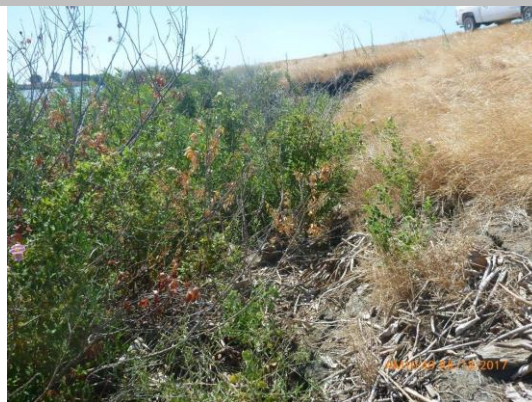
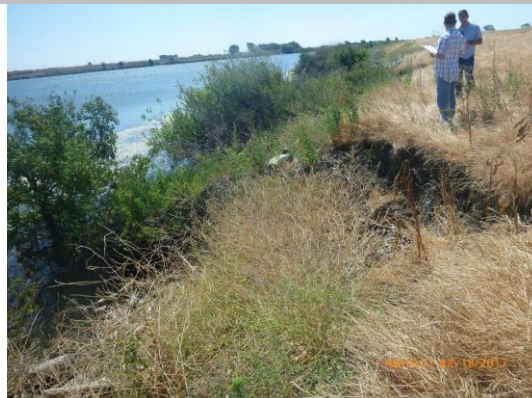
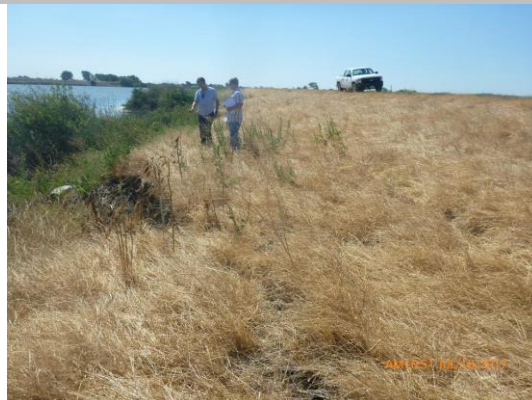
LM Start	2.56	Rating **	A/W	Issue No.	34
LM End	2.58	Issue Type +	Ma	Location *	
Category	Supplemental			GPS Latitude/Longitude	
				Start	End
Item	2017 Storm Damage			38.277850°	38.277706°
				-121.712639°	-121.712414°
DWR ID	DWR_RD2060_03_f_2017_34				
Comment Code					
Inspector Comment					
Levee Evaluation Comments					
Description:Erosion commences approximately 1/4 of the way down the slope and results in sloughing into the waterside toe.					
Site ID No:403					
Site Designation:LMA-230					
Repair Type: Erosion					
Rating:Serious					
Field Date:7/18/2017					
Notes: Erosion causing sloughing. Horizontal cracks about 6' up from erosion.

LM Start	2.56	Rating **	A/W	Issue No.	34 (cont)
LM End	2.58	Issue Type +	Ma	Location *	
Category	Supplemental			GPS Latitude/Longitude	
				Start	End
Item	2017 Storm Damage			38.277850°	38.277706°
				-121.712639°	-121.712414°
DWR ID	DWR_RD2060_03_f_2017_34				
Comment Code					
Inspector Comment					
Levee Evaluation Comments					
Description:Erosion commences approximately 1/4 of the way down the slope and results in sloughing into the waterside toe.					
Site ID No:403					
Site Designation:LMA-230					
Repair Type: Erosion					
Rating:Serious					
Field Date:7/18/2017					
Notes: Erosion causing sloughing. Horizontal cracks about 6' up from erosion.

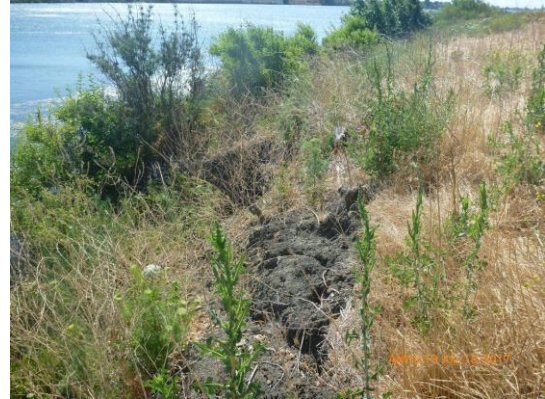
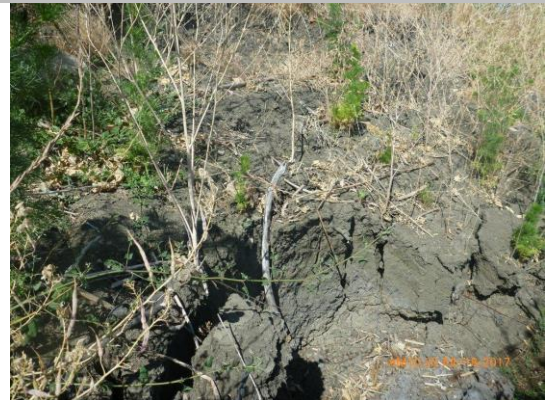
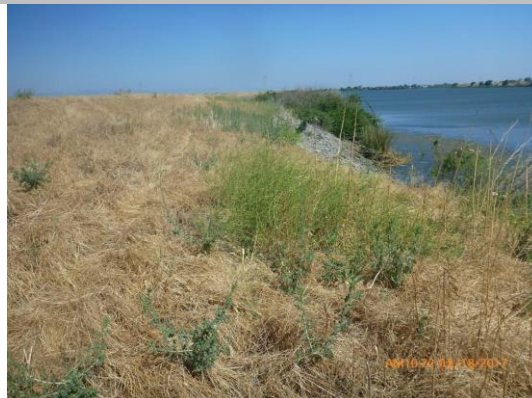
LM Start	2.64	Rating **	M	Issue No.	35 (cont)	
LM End	2.64	Issue Type +	Ma	Location *		
Category	Supplemental			GPS Latitude/Longitude		
				Start	End	
Item	2017 Storm Damage			38.277106°	38.277078°	
				-121.711489°	-121.711447°	
DWR ID	DWR_RD2060_03_f_2017_35					
Comment Code						
Inspector Comment						
Levee Evaluation Comments						
Description:Erosion commences approximately 1/4 of the way down the slope and results in sloughing into the waterside toe.						
Site ID No:404						
Site Designation:LMA-231						
Repair Type: Erosion						
Rating:Area of Concern						
Field Date:7/18/2017						
Notes: Small erosion and sloughing adjacent to revetted slope.

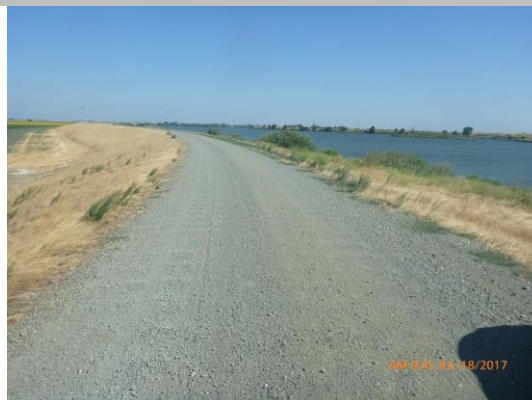
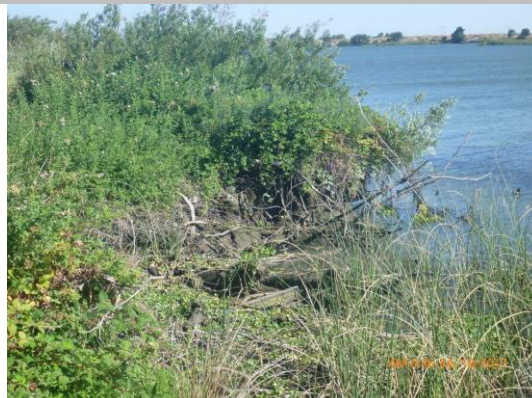
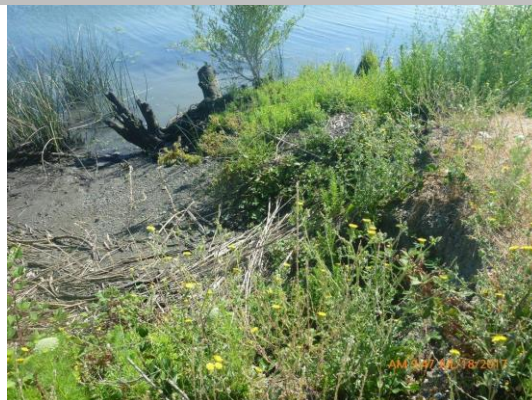
LM Start	2.69	Rating **	A/W	Issue No.	36
LM End	2.73	Issue Type +	Ma	Location *	
Category	Supplemental			GPS Latitude/Longitude	
				Start	End
Item	2017 Storm Damage			38.276608 °	38.276133 °
				-121.710811 °	-121.710394 °
DWR ID	DWR_RD2060_03_f _ 2017_36				
Comment Code					
Inspector Comment					
Levee Evaluation Comments					
Description:Sloughing commences approximately halfway down the slope and extends to the waterside toe.					
Site ID No:405					
Site Designation:LMA-232					
Repair Type: Erosion					
Rating:Serious					
Field Date:7/18/2017					
Notes: Vertical cut at highwater mark.

LM Start	2.69	Rating **	A/W	Issue No.	36 (cont)	
LM End	2.73	Issue Type +	Ma	Location *		
Category	Supplemental			GPS Latitude/Longitude		
				Start		End
Item	2017 Storm Damage			38.276608 °		38.276133 °
				-121.710811 °		-121.710394 °
DWR ID	DWR_RD2060_03_f_2017_36					
Comment Code						
Inspector Comment						
Levee Evaluation Comments						
Description:Sloughing commences approximately halfway down the slope and extends to the waterside toe.						
Site ID No:405						
Site Designation:LMA-232						
Repair Type: Erosion						
Rating:Serious						
Field Date:7/18/2017						
Notes: Vertical cut at highwater mark.

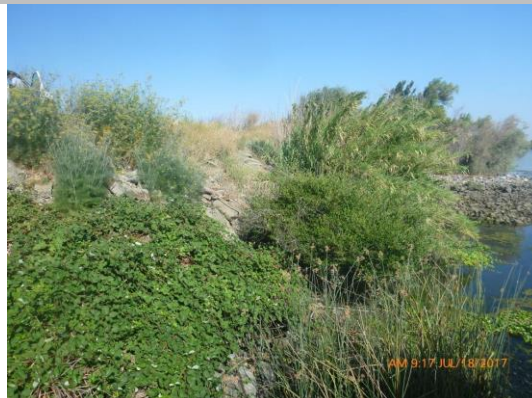
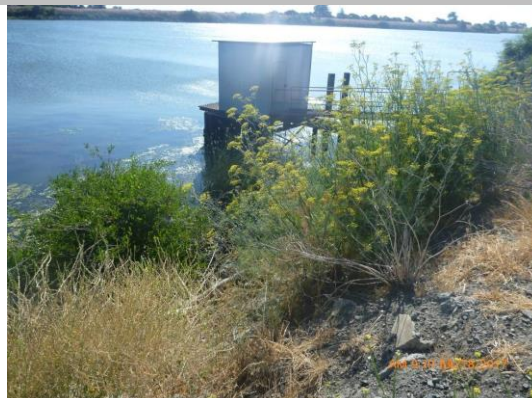
LM Start	3.24	Rating **	M	Issue No.	37	
LM End	3.24	Issue Type +	Ma	Location *		
Category	Supplemental			GPS Latitude/Longitude		
				Start	End	
Item	2017 Storm Damage			38.270231 °	38.270203 °	
				-121.705897 °	-121.705856 °	
DWR ID	DWR_RD2060_03_f_2017_37					
Comment Code						
Inspector Comment						
Levee Evaluation Comments						
Description:Erosion commences approximately halfway down the slope and results in sloughing into the waterside toe. Existing rip rap has been pulled off the slope at this site.						
Site ID No:406						
Site Designation:LMA-233						
Repair Type: Erosion						
Rating:Area of Concern						
Field Date:7/18/2017						
Notes: Erosion is next to a pumphouse and slope is protected withrip rap.

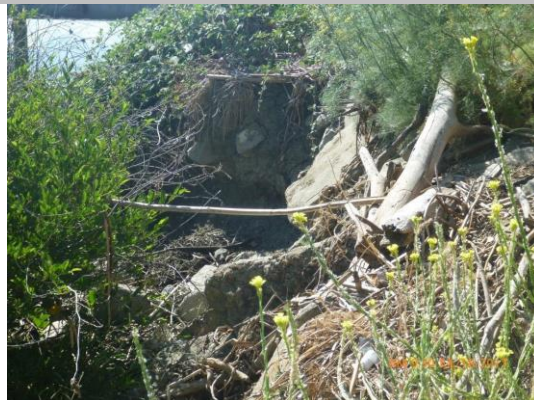
Photo 3 of 3 : FA_2018_RD2060_243_37_20180925_00063.jpg

LM Start	3.24	Rating **	M	Issue No.	37 (cont)	
LM End	3.24	Issue Type +	Ma	Location *		
Category	Supplemental			GPS Latitude/Longitude		
				Start	End	
Item	2017 Storm Damage			38.270231 °	38.270203 °	
				-121.705897 °	-121.705856 °	
DWR ID	DWR_RD2060_03_f_2017_37					
Comment Code						
Inspector Comment						
Levee Evaluation Comments						
Description:Erosion commences approximately halfway down the slope and results in sloughing into the waterside toe. Existing rip rap has been pulled off the slope at this site.						
Site ID No:406						
Site Designation:LMA-233						
Repair Type: Erosion						
Rating:Area of Concern						
Field Date:7/18/2017						
Notes: Erosion is next to a pumphouse and slope is protected withrip rap.

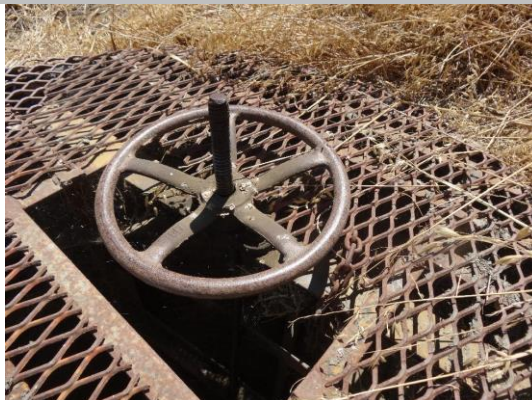
Photo 2 of 3 : UCIP_FA_2018_18723_31302.jpg

LM Start	3.24	Rating **	M	Issue No.	74 (cont)	
LM End	3.24	Issue Type +	En	Location *		
Category	Supplemental			GPS Latitude/Longitude		
				Start	End	
Item	DWR UCIP Field Study			38.270151 °	38.270151 °	
				-121.705782 °	-121.705782 °	
DWR ID	22064					
Comment Code						
Inspector Comment						
FS_ID:18723						
DS_ID:22064						
EP_NO: N/A						
Repair Type: Non-Urgent						
Crossing Status: Indicator Found						
UCIP Comments: Only a CMP riser was found on WS.						
FIELD_STRUCT_DESC: 36-inch asbestos bonded steel irrigation						
discharge pipe through the levee, 15 feet below the crown, not found.						
Slide gate in a corrugated metal pipe (CMP) riser on the waterside (WS)						
slope, found. Pump in pump house on a pile structure in the stream, not						
found. Service pole and anchor on the landside (LS) slope, not found.						
FS Date: 8/15/2013

WS view: closer view of slide gate in CMP riser.

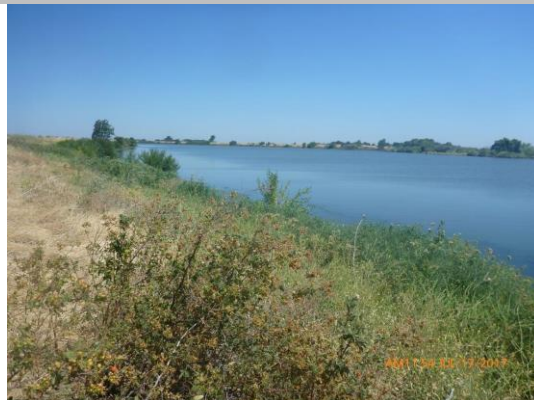
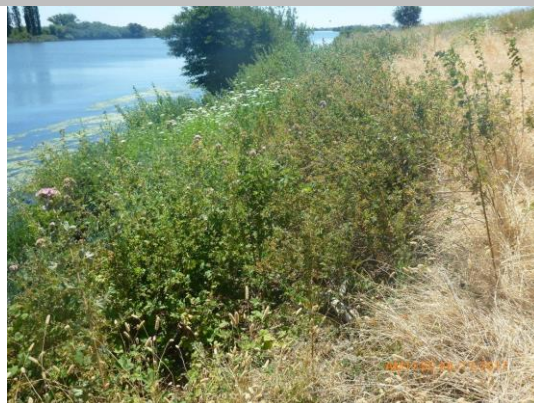
LM Start	4.06	Rating **	A/W	Issue No.	42
LM End	4.08	Issue Type +	Ma	Location *	
Category	Supplemental			GPS Latitude/Longitude	
				Start	End
Item	2017 Storm Damage			38.260789 °	38.260644 °
				-121.696964 °	-121.696828 °
DWR ID	DWR_RD2060_03_f_2017_42				
Comment Code					
Inspector Comment					
Levee Evaluation Comments					
Description:Erosion commences approximately halfway down the slope and results in sloughing into the waterside toe. Existing rip rap has been pulled off the slope at this site.					
Site ID No:412					
Site Designation:LMA-239					
Repair Type: Erosion					
Rating:Serious					
Field Date:7/17/2017					
Notes: Small erosion. Appears that site grows slowly with each high water. The center of the eosion is a deep cut that extends below rhe waterline. Possible beaver den collapse.
